## Effects on Diagnostic Parameters After Removing Additional Synchronous Gear Meshes

Harry J. Decker U.S. Army Research Laboratory, Glenn Research Center, Cleveland, Ohio

Prepared for the 57th Meeting of the Society for Machinery Failure Prevention Technology (MFPT) cosponsored by the Office of Naval Research (ONR), the National Aeronautics and Space Administration (NASA), the U.S. Army Research Laboratory (ARL), and the Naval Surface Warfare Center (NSWC)

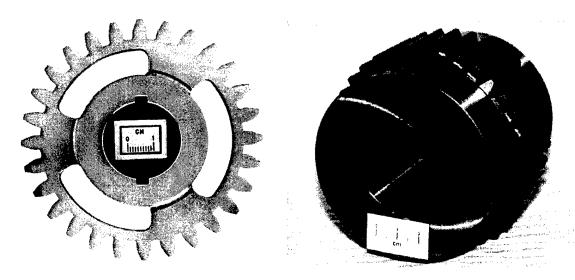
Figure 3. Sample gear for crack test

Gear descriptions: The test rig uses a pair of spur gears having 28 teeth, a pitch diameter of 88.9 mm (3.50 inch), and a face width of 6.35 mm (0.25 inch). During a surface fatigue test, the gear faces are offset by 2.8 mm (0.11 inch) to allow a higher surface stress without a corresponding increase in the bending stress. For bending fatigue tests, however, the gears are in contact across the full face width. The tests are also run at a higher torque than normal to assist in the formation of a crack front. A photograph of a test gear is shown in Figure 3.

<u>Notch geometry:</u> For bending fatigue tests, a notch is machined in the root area of the gear to provide a concentrated flaw from which a crack could initiate. This location is the point of highest tensile stress on the gear tooth root-fillet region. The higher stress provides the best opportunity for crack propagation.

The notch traverses the entire face width of the gear and is created using electrical discharge machining (EDM); this process is chosen for its ability to control the size of the notch. The size of the notch is controlled by both the shape and electric current of the electrode and is typically 0.254 mm (0.010 inch) deep.

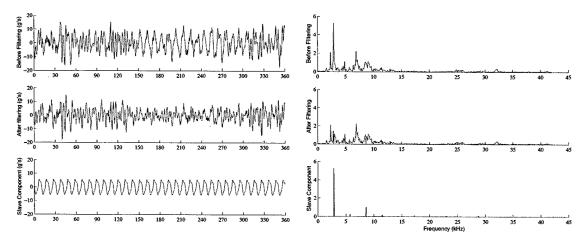
Figure 5. Effects of slave mesh filtering

Figure 5 illustrates the effect that other synchronous gear meshes can have on a vibration signal. In the uppermost plot, the synchronously averaged vibration is plotted as a function of angular position during one revolution. The middle plot shows the result of removing the slave gear mesh and its harmonics (not including those that are coincident with the test gear harmonics). Finally, the lower plot shows the contribution due to the slave gear mesh.

The frequency domain representation is presented in Figure 6. The plot on the bottom clearly indicates that all spectral lines associated with the slave gear mesh (with the exception of those that are coincident with the harmonics of the test gear) have been removed.
